NBSIR 76-1132

Personnel Guardrails for the Prevention of Occupational Accidents

Final Report

Prepared for
Occupational Safety and Health Administration
Department of Labor
Washington, D. C. 20210

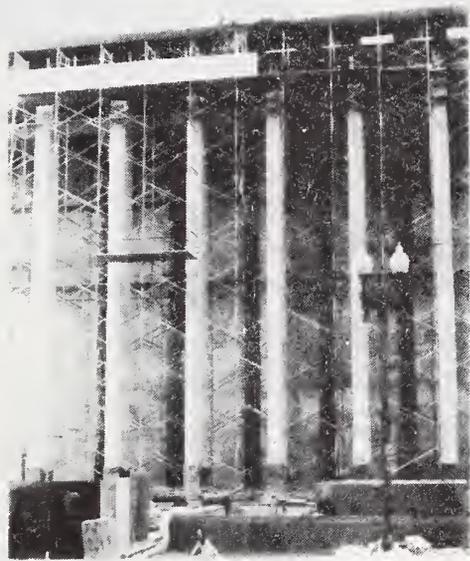
Figure 4.3 Temporary guardrails used during construction of a multi-story library building.

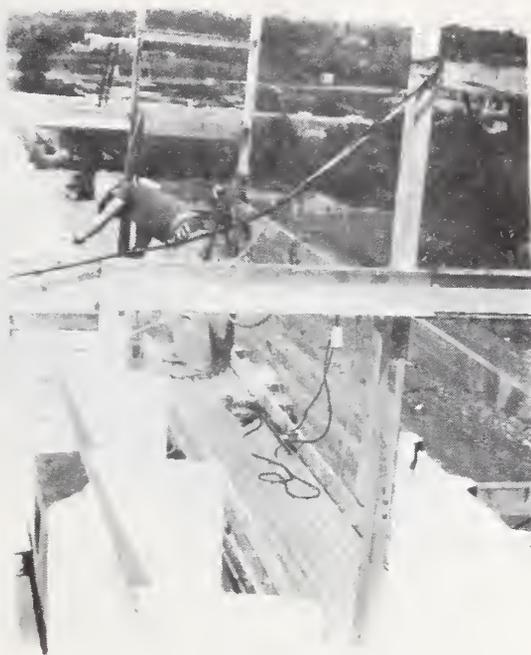
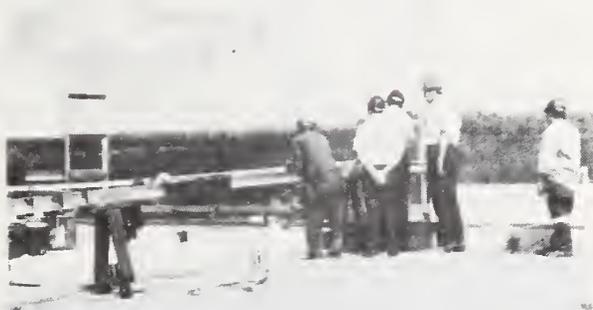
The top rail was a 2-in by 6-in (5.08-cm by 15.24-cm), nominal wood board, about 42 in (106.7 cm) above the tread. Although this rail was intended to serve as a lifeline as well as a barrier, it appeared to be structurally quite inadequate to support the impact load of a falling human subject transmitted through the lanyard. The wood toeboard was 1 in by 4 in (2.54 cm by 10.16 cm), nominal. There were no intermediate rails. Suspended from the roof by a counterweight device mounted on wheels (figure 4.4 b), the scaffold could be moved easily along the building perimeter. Roofers were working at the same time as the men on the scaffold and the perimeter guarding system for the roofers was either removed or being laid down to allow the mobile scaffold support system to move along the building edge. This was the first observation of a conflict between a safety requirement for one trade and the construction method of another.

Figure 4.4 Temporary guardrails on scaffolds or staging platforms used during construction of pharmaceutical building.

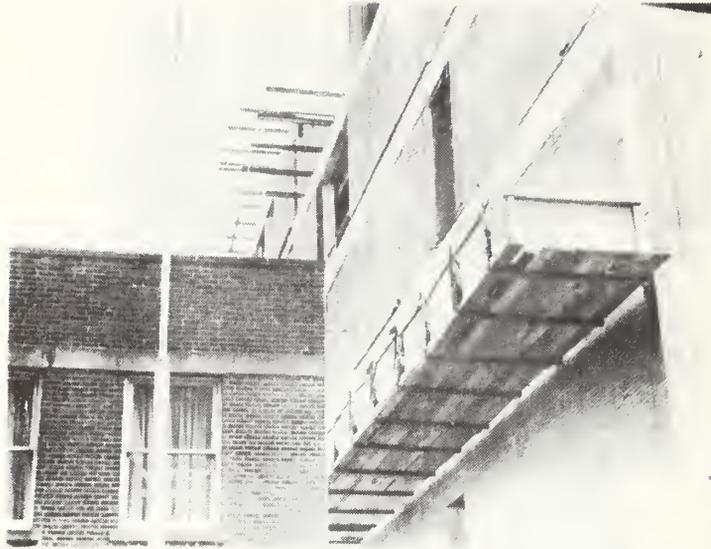
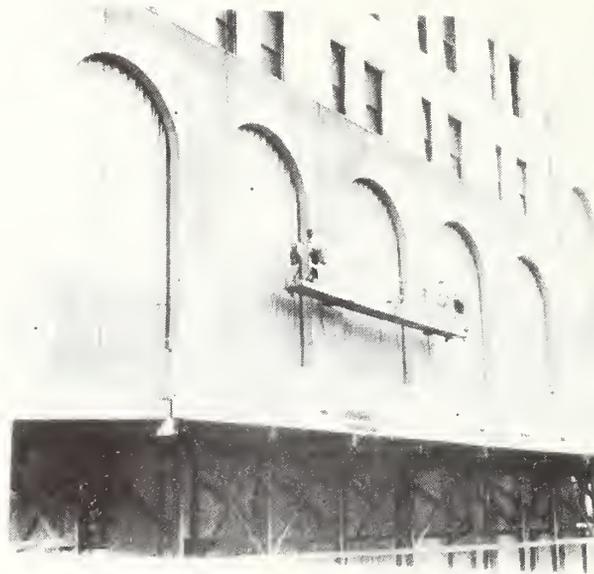
Two sites of suspended scaffolds were examined while passing buildings where construction activity was occurring (figure 4.5). For one instance, the scaffold was being used by bricklayers (figures 4.5 a). It was constructed entirely of wood. The guardrail consisted of plywood boards attached to vertical wood posts joined by horizontal members at the top. The second scaffold was located at the site of a building being remodelled (figure 4.5 b). It appeared to have a metal plank floor and no guardrails at the ends or at the side nearest the building. At the far side, the wood guardrail consisted of top and intermediate rails and a toeboard, all supported by two end posts estimated to be at least 20 ft (6.1 m) apart. This spacing was judged to be excessive in relation to the apparent size of the

Figure 4.5 Examples of temporary guardrails on suspended scaffolds used in construction, maintenance or renovation of buildings.

top rail to prevent a structural failure in the event of an accidental fall of the employee against the guardrail.

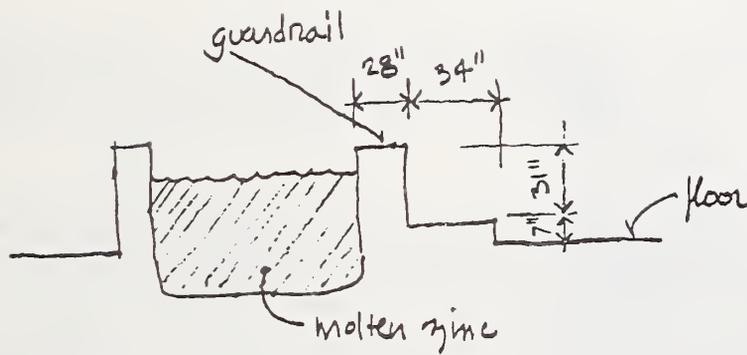
Figure 4.8 First example of wall barrier around molten zinc kettle used in galvanizing operations.

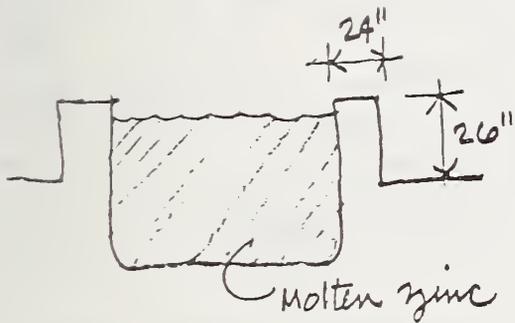
(the foreground area shown in Figure 4.9 b) caused a reduction in the wall height at that location and consequently in its effectiveness to function as a safety barrier.

Figure 4.9 Second example of wall barrier around molten zinc kettle used in galvanizing operations.

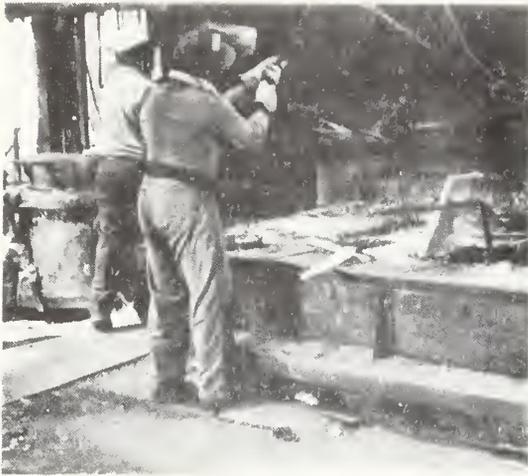
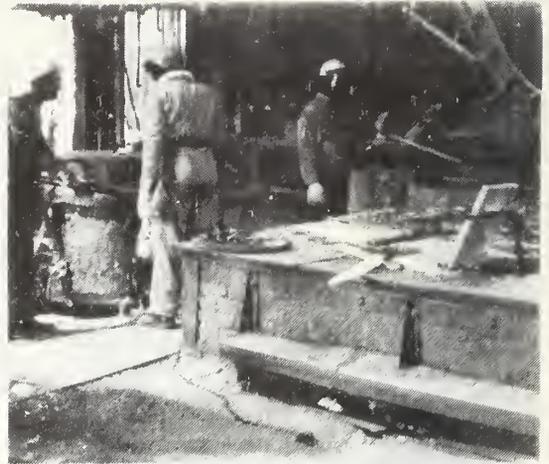
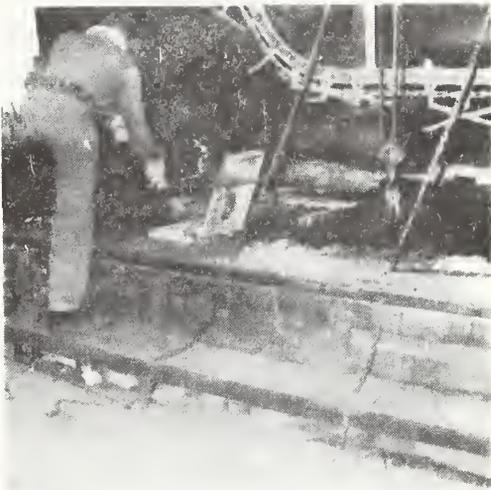
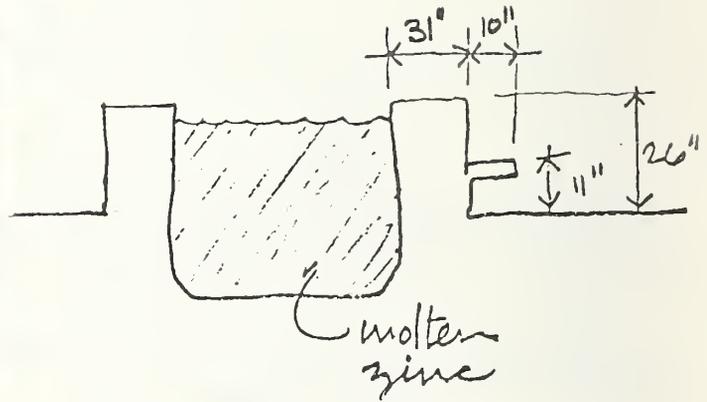
Besides the activities noted earlier, this operation required manipulation of the chain-pulley assembly to lower or raise the objects being galvanized. The kettle was equipped with a ledge which provided a bearing surface for the foot to facilitate pulling the object out of the vat. However, the ledge reduced the effective height of the barrier and encouraged hazardous postures, for the purpose of gaining reach advantage, such as shown in Figure 4.10 c.

Figure 4.10 Third example of wall barrier around molten zinc kettle used in galvanizing operations.

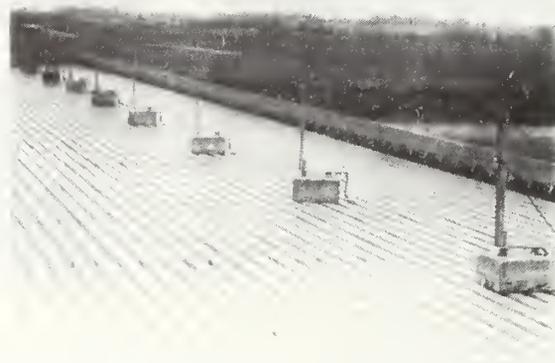
The symbolic guardrail consisted of two 1/4-in (0.64-cm) wire ropes clamped to steel posts attached to 40-lb (178-N) cast concrete blocks at the base. Trials were being made to increase the lateral stability of the posts through adhesion of stick clips with the tar surface (figure 4.12 b). Without such adhesion, a 6 lb. (26.7N) horizontal force applied to the top of the post would cause it to overturn.

Figure 4.11 Symbolic guardrails used in built-up roofing operations.

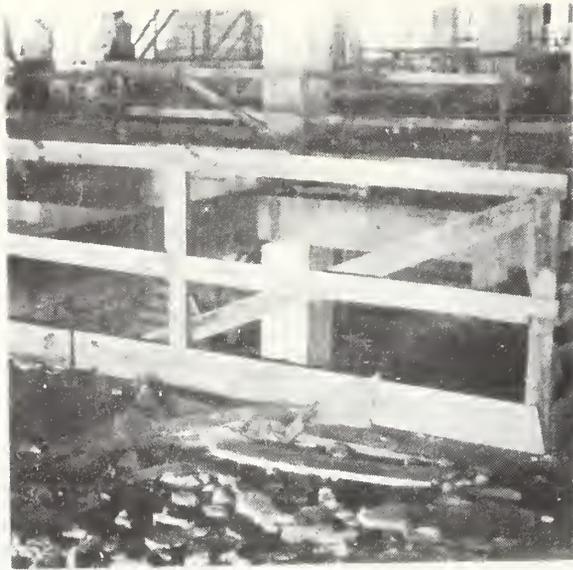
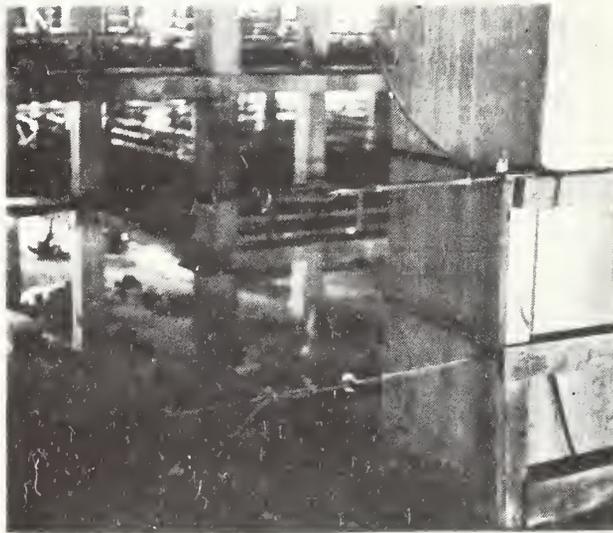
There were two types of guardrails installed around the opening. One was constructed of wood (figure 14.a) with a 42-in (106.7-cm) high top rail and 24-in (61-cm) high intermediate rail. The spacing of the vertical posts varied from 5 ft to 7 ft (1.5 m to 2.1 m) on centers and the toeboard height varied from 4 in to 10 in (10.16 cm to 25.4 cm). The wood members were typically 2 in by 4 in (5.08 cm by 10.16 cm), nominal, and were fastened together with nails. The second type (figure 14.b) used 1/2-in (1.27-cm) wire rope top and intermediate rails, 43 in (109.2 cm) and 22 in (55.8 cm) from the tread, respectively. The vertical wood supports were spaced between 5 ft to 7 ft (1.5 to 2.1 m) on centers. The wood toeboard was 6 in (15.2 cm) high. The wire ropes were looped around and tied to concrete columns located along the periphery of the openings. They were kept taut by means of turnbuckles.

Figure 4.14 Temporary guardrails installed around openings during construction of multi-story buildings.

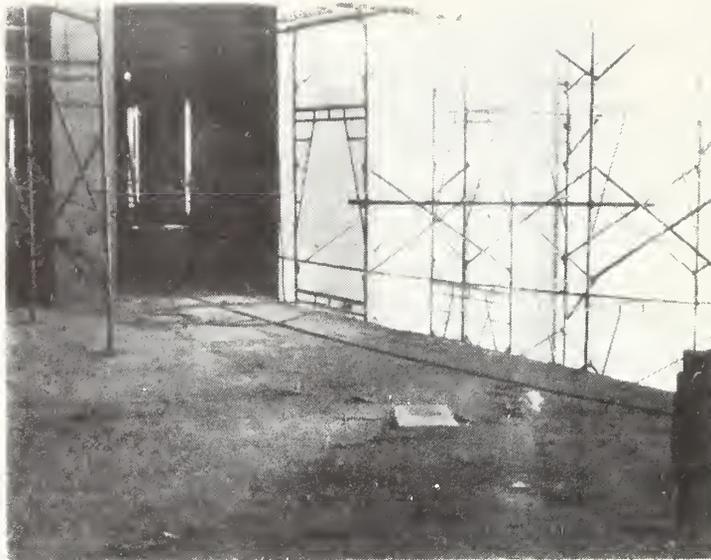
The guardrail consisted of two wire ropes loosely attached to two of the building columns approximately 30 ft (1.4 m) apart. The top rail was 35 in (89 cm) high and the intermediate rail was 14 in (35.6 cm) high. There were no toeboards.

Figure 4.15 Temporary guardrails around storage area used during construction of multi-story building.

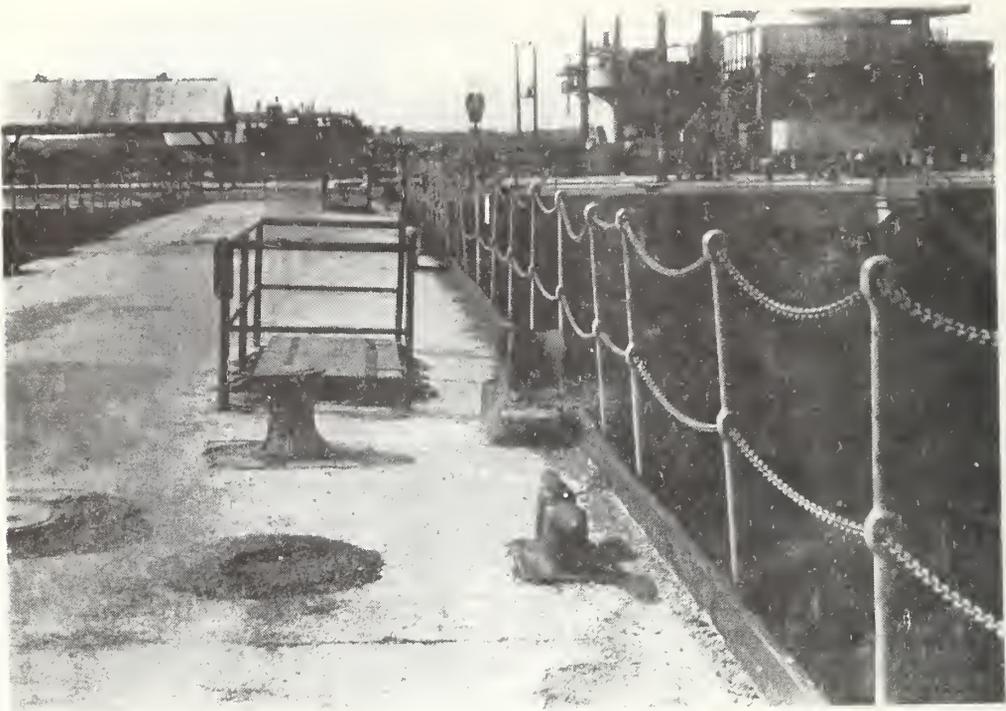
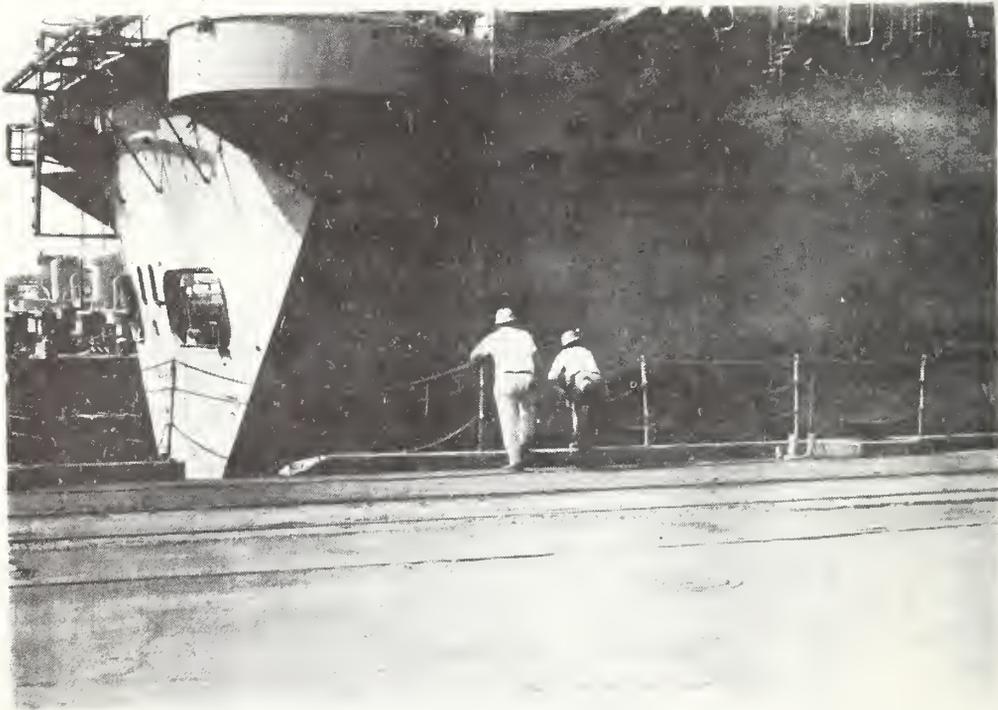
The warning signs were not always effective in discouraging employees from leaning against the guardrail to observe activities in the dry dock area (figure 4.17 b). There were no other activities observed except employees walking past the guardrail.

The guardrail was visible at all locations visited. There was evidence of corrosion which is probably aggravated by the proximity of a large body of water as well as by rain and humidity. Another potentially hazardous condition experienced was the occurrence of high wind gusts in the general vicinity of the guardrail.

The guardrail consisted of cast steel posts spaced at 7.25 ft (2.2 m) on centers, a set of 2 or 3 steel chain rails passing through slots in the posts and occasionally, a 7-in (17.8-cm) high concrete curb or metal toeboard (figure 4.17). Despite the warning sign, at first glance the guardrail could convey the false (and dangerous) impression of being structurally sturdier than it actually is. This is partly due to the fact that the chains are installed with a built-in slack and are not constrained from sliding through the slots. Consequently, a force applied to the rail will cause it to sag excessively by taking up the slack from the adjacent spans as in figure 4.17(b). It also appeared that some of the post anchorages would not be capable of transmitting lateral forces to the foundation because of either loose fittings, or insufficient edge distance.

Figure 4.17 Permanent symbolic guardrails installed at marine dry dock facility.

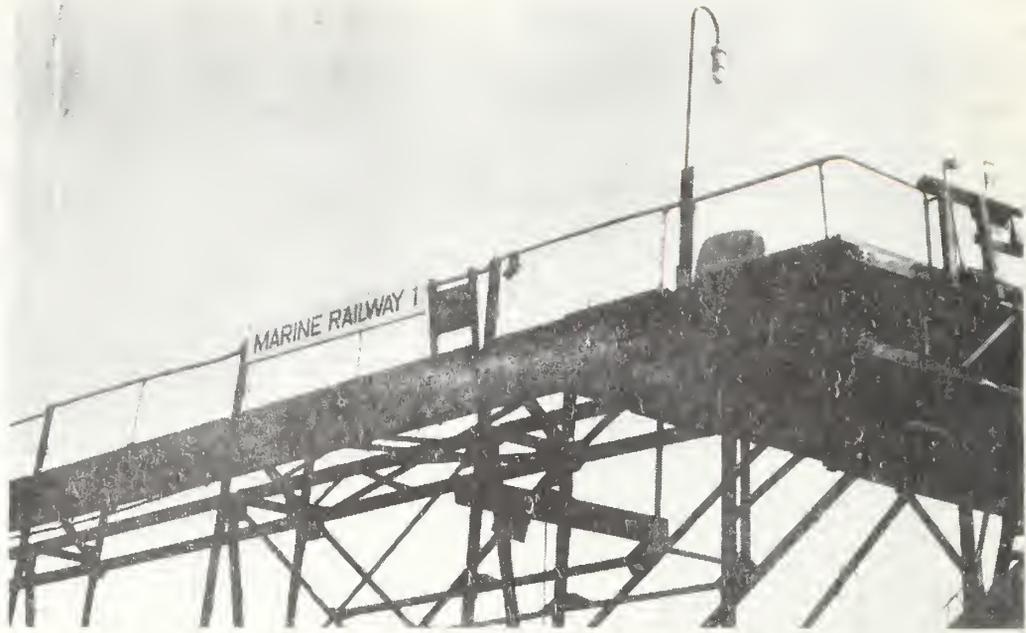
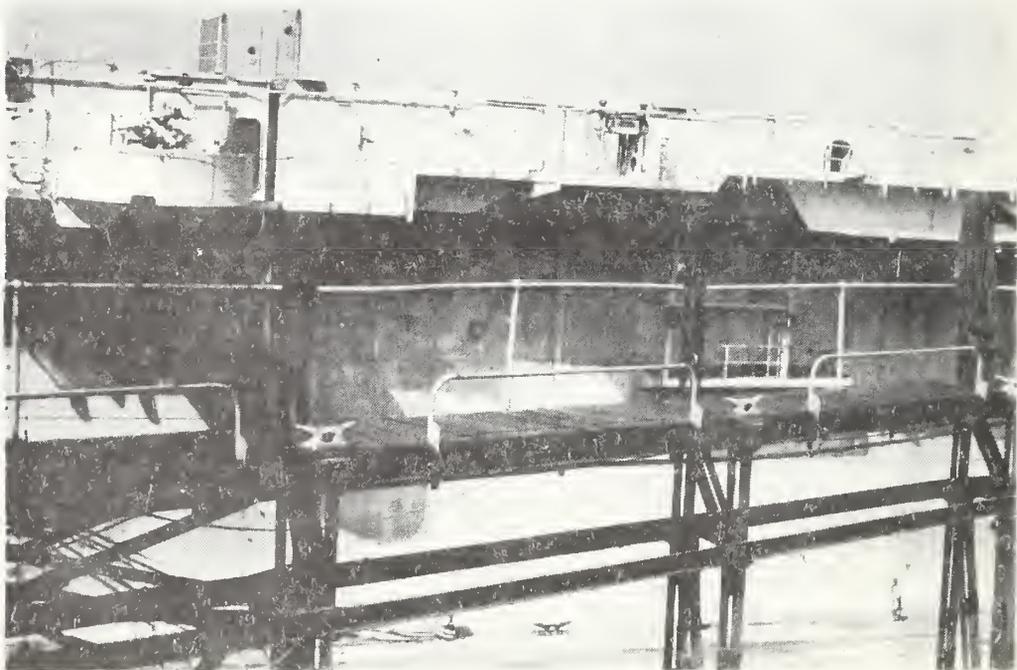
There were different guardrails on each side of the walkway. On the outside (the side away from the ship being worked on), the top rail was 37.5 in (95.2 cm) high with vertical supports at 5 ft (1.5 m) on centers (figure 4.18 a). There was no intermediate rail or toeboard. The top rail and vertical supports were made of steel pipe connected by bolts and welded joints. On the side adjacent to the ship, the guardrail was a series of sections of steel pipe 17.5 in (44.4 cm) high by approximately 6 ft (1.83 m) long (figure 4.18 b). The sections were spaced approximately 4 ft (1.22 m) apart. Connections were made by bolts and welded joints. The size and design of the rail appeared to provide little protection from falls.

Figure 4.18 Permanent guardrails on elevated catwalks.
